Test Report

No.: CANEC23000139401

Sample Name: 9080HL

Halogen

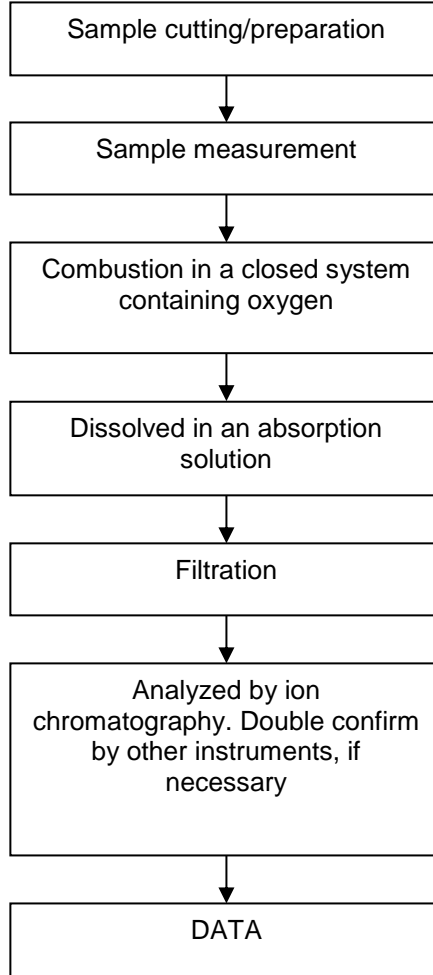
Halogen Testing Flow Chart

Test Method: With reference to EN 14582:2016, analysis was performed by IC.

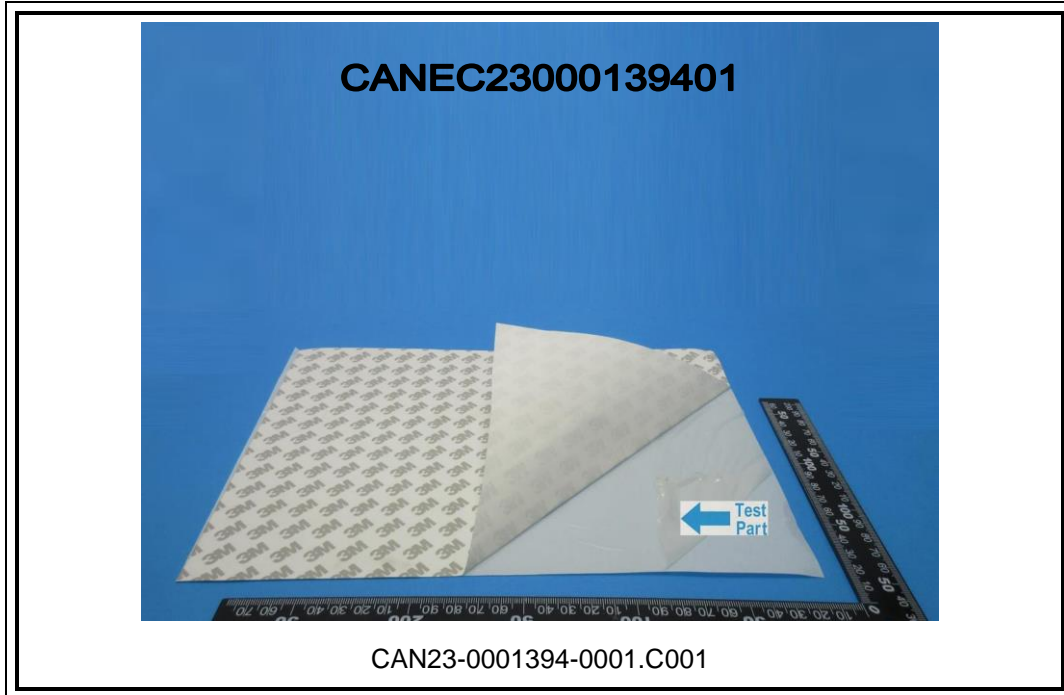
Sample Photo:

SN ID	Sample No.	SGS Sample ID	Description
SN1	A1	CAN23-0001394-0001.C001	Colorless transparent double-side adhesive sheet
