## Test Report

No.: SHAEC23016094903

Sample Name: 3M 9077

## Halogen

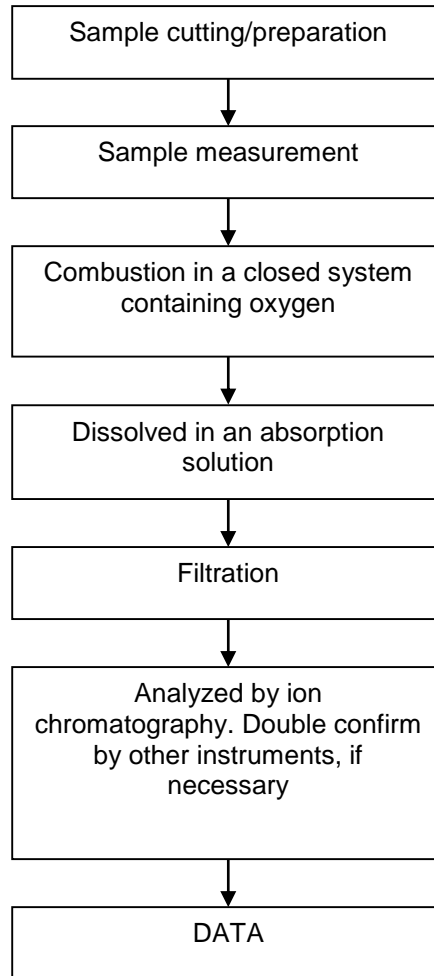
## Halogen Testing Flow Chart

Test Method: With reference to EN 14582:2016, analysis was performed by IC.

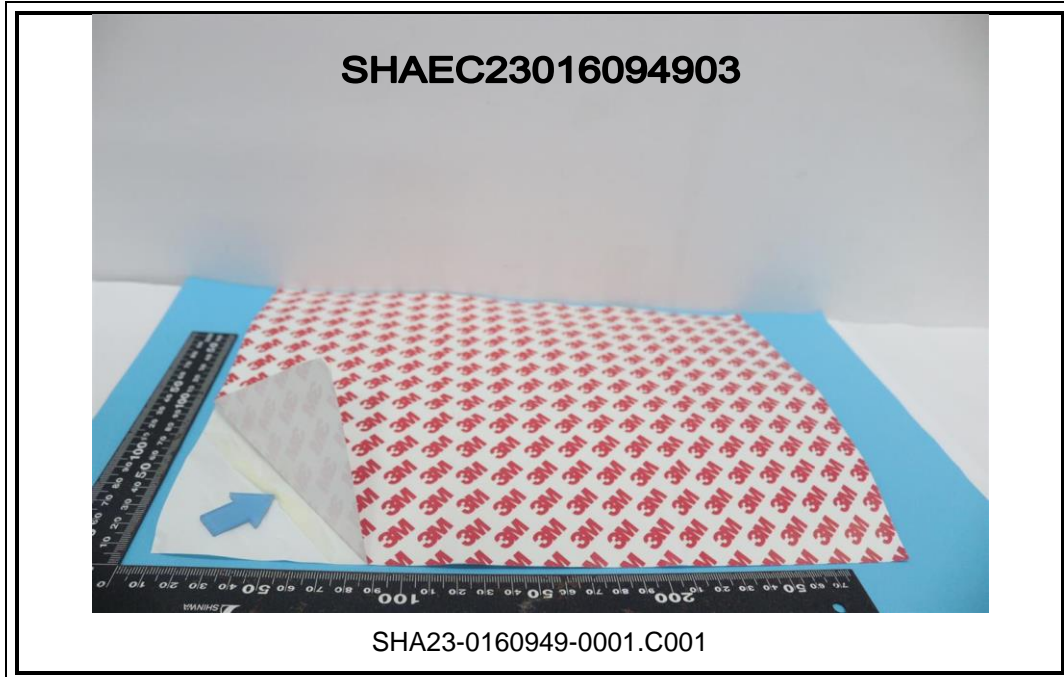
Sample Photo:

SN ID	Sample No.	SGS Sample ID	Description
SN1	A1	SHA23-0160949-0001.C001	Colorless transparent adhesive film
